INVENTORY OF MONUMENTS AT PAGAN

Volume One
Monuments 1-255

PIERRE PICHARD

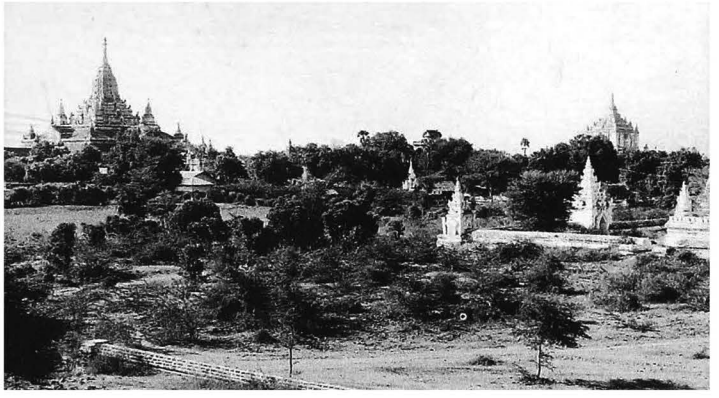
5 present condition
- brick debris from various sizes.
- height: approx. 1.20 m.

1932 b - From north-east, together with 2171 Ananda in background

1932 c - From west, together with 1931 in background

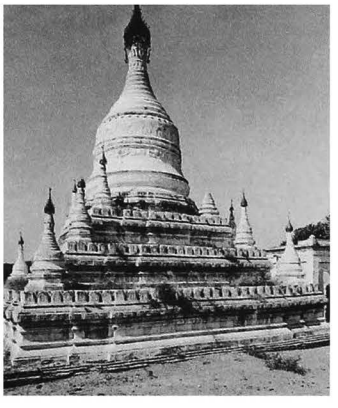
5 present condition
- maintained and whitewashed.

1934 d - East face, from south-east

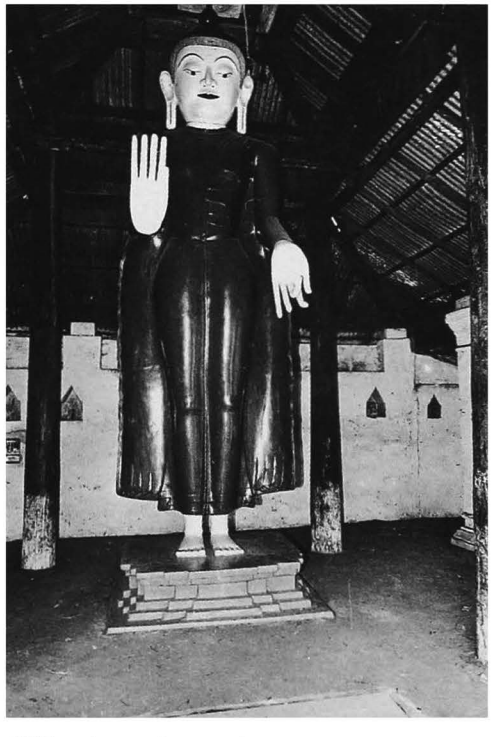
5 present condition
- recently repainted.

1938 c - Image, from east

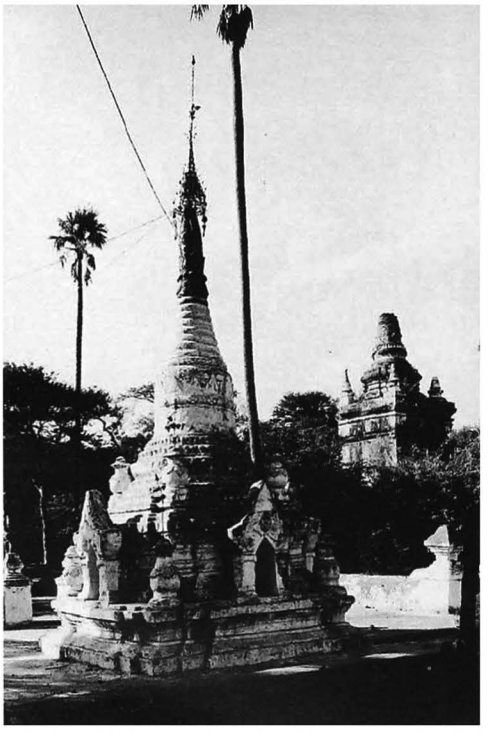
5 present condition
- formerly whitewashed.
- no maintenance.
- upper parts badly damaged.

1941 b - From north-east, together with 1940 in foreground

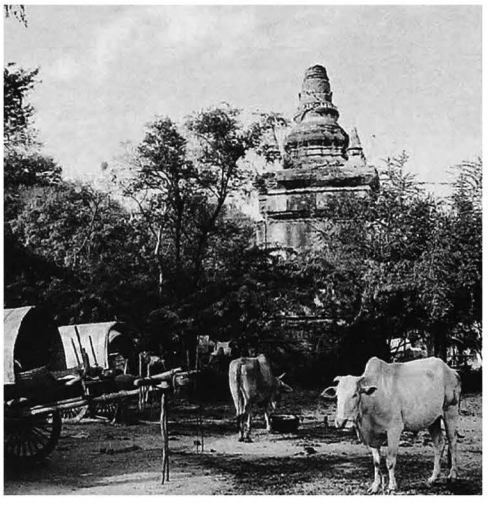
1941 c - From east

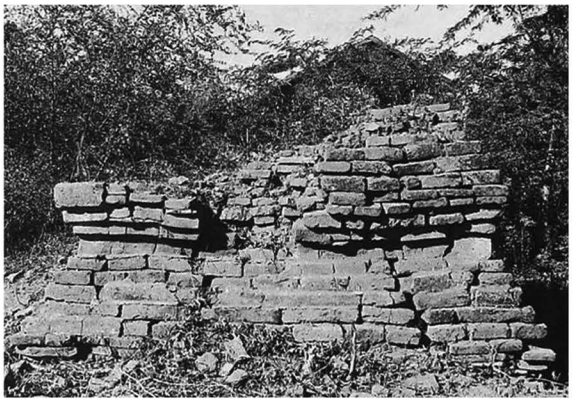
5 present condition
- ruined.
- terraces disintegrated.
- upper parts destroyed.

1949 b - From north-east

1949 c - East face

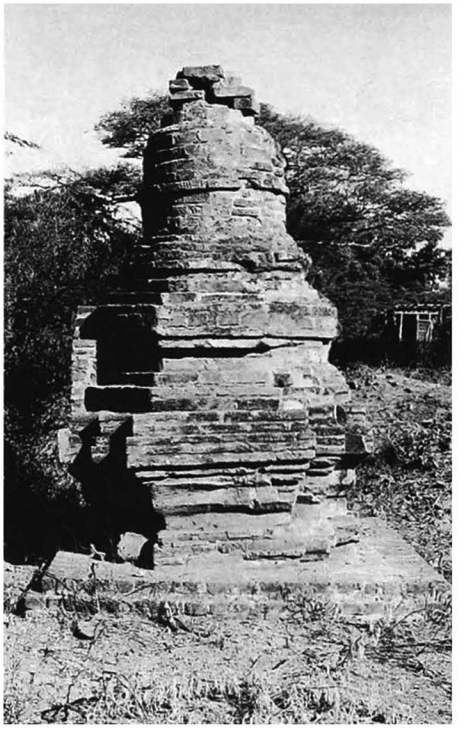
1953 d - South face

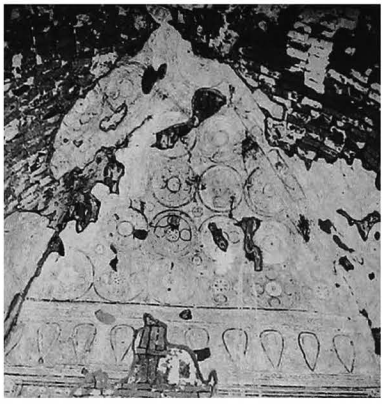
1954 f - Shrine vault from north

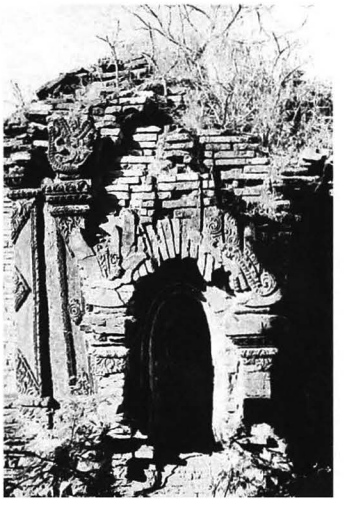
1958 b - East forepart (1988)

5 present condition
- restored (Arch. Dept.) 1989.

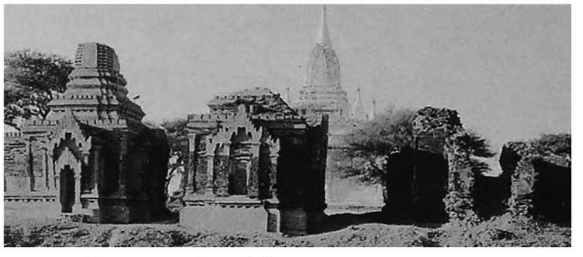
1959 c - From south (1990), between 1958 and 1960

5 present condition
- vaults and upper parts collapsed.
- repaired (Arch. Dept.) 1989.

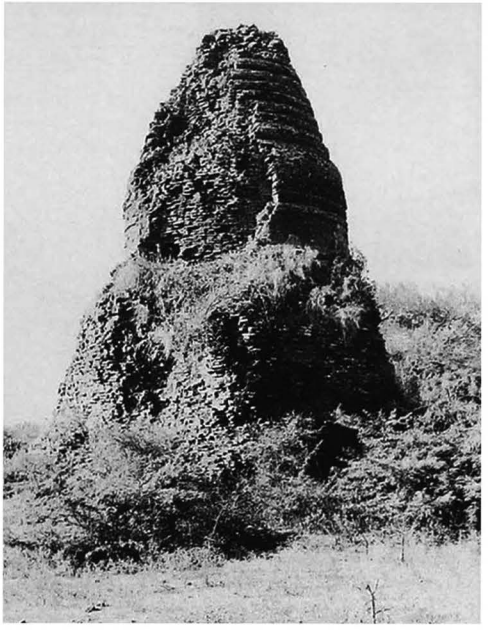
1965 b - From north-east

5 present condition
- no maintenance.
- terraces disintegrated.
- upper parts damaged.

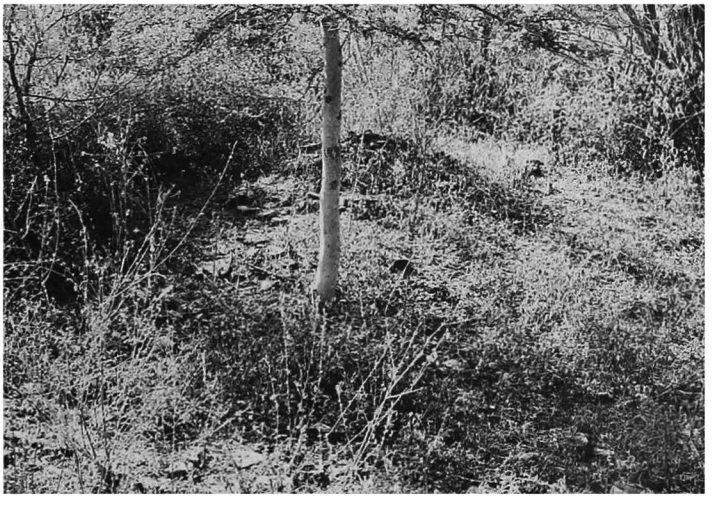
5 present condition
- brick debris.
- present height: approx. 1.30 m.

1971 b - From north

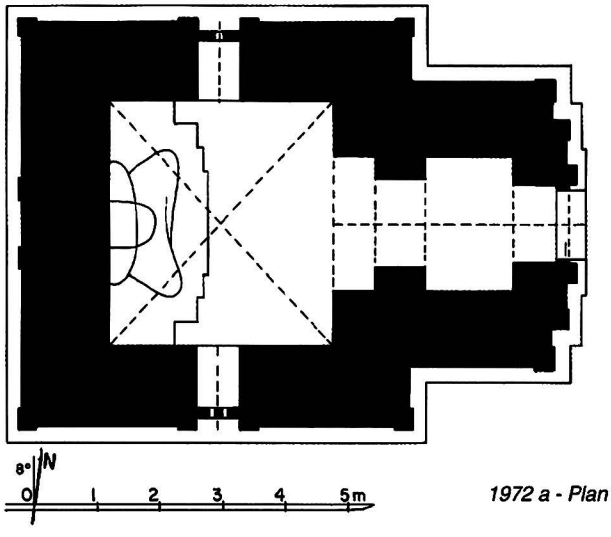
1972 a - Plan

5 present condition
- no maintenance.
- upper parts damaged.

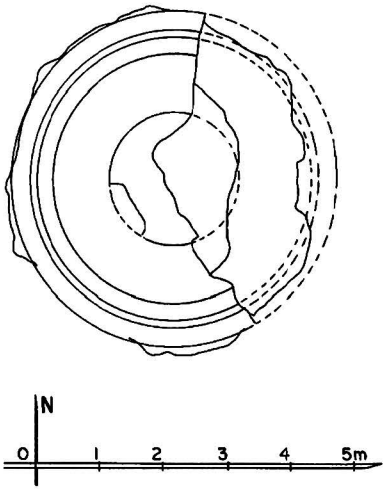
1973 a - Plan

5 present condition
- half-ruined and endangered.
- base and terraces disintegrated.
- upper parts badly damaged.

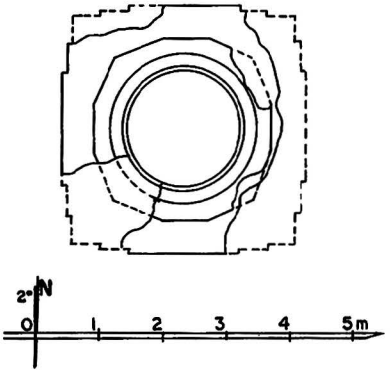
1974 a - Plan

5 present condition
- no maintenance.
- badly damaged.

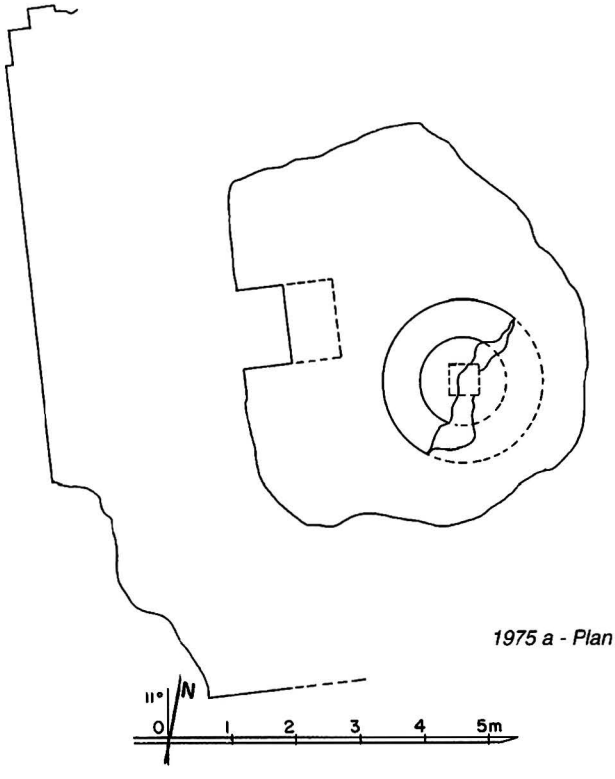
1975 a - Plan

5 present condition
- half-ruined.
- terraces disintegrated.
- upper parts badly damaged.

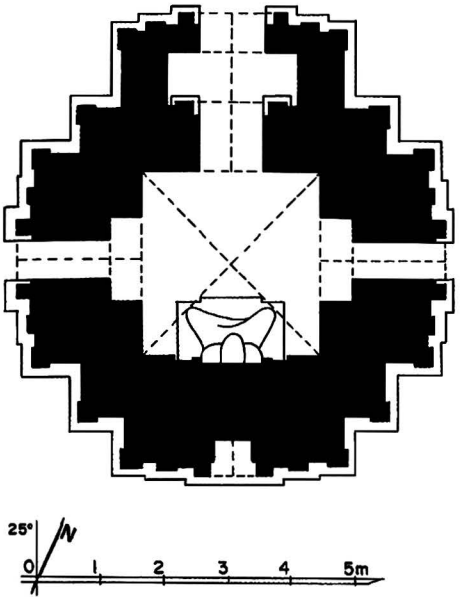
1977 a - Plan

5 present condition
- no maintenance.
- structure badly cracked.

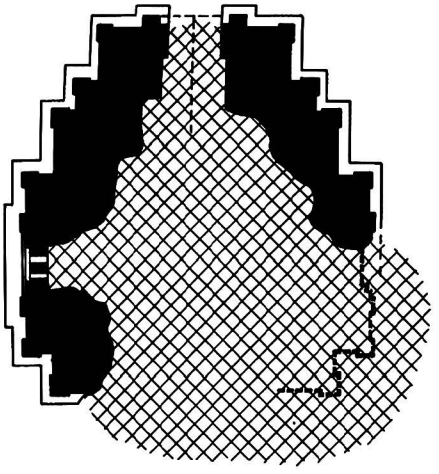
1978 a - Plan

5 present condition
- ruined.
- south-east corner, vaults and upper parts collapsed.
- ground floor buried under debris.

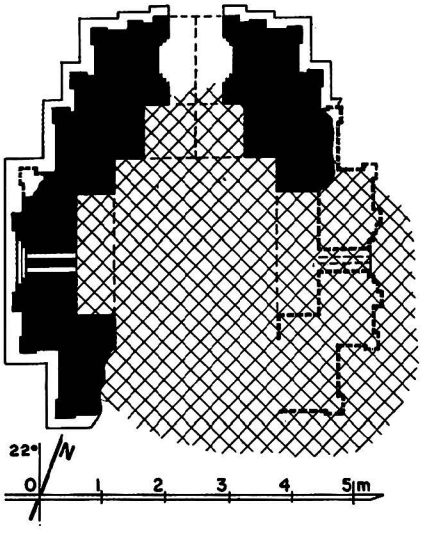
1979 a - Plan

5 present condition
- ruined.
- south-east corner, vaults and upper parts collapsed.
- ground floor buried under debris.

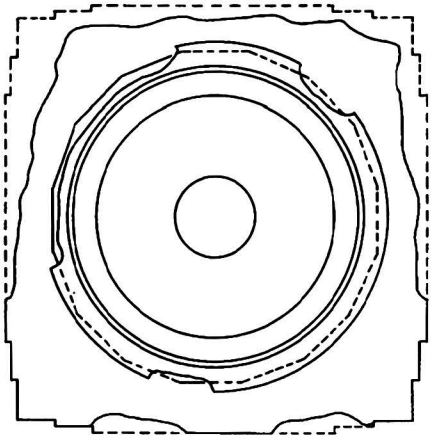
1982 a1 - Plan

5 present condition
- half-ruined.
- terraces disintegrated.
- upper parts badly damaged.

remark
- the dome was enlarged before the first one was completed, the upper terrace under the final dome was 16-sided.

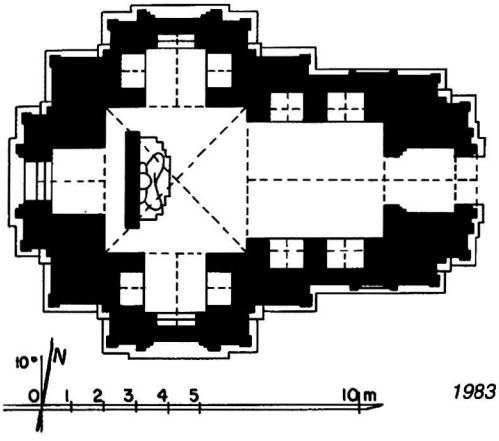
1983 a - Plan

5 present condition
- no maintenance.
- upper parts badly damaged.
- structure badly cracked.

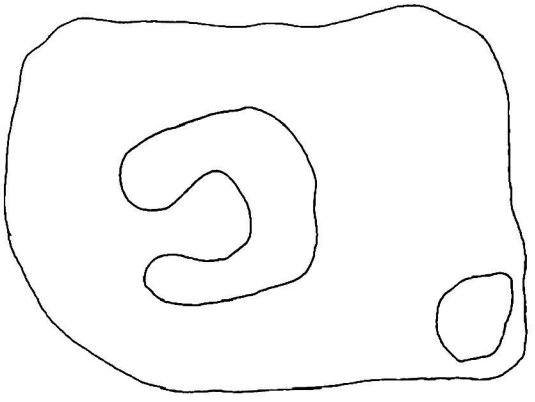
1989 a - Plan

5 present condition
- brick debris from size 28 x 14 x 4.5 cm, and stone pieces.
- present height: approx. 2.00 m.

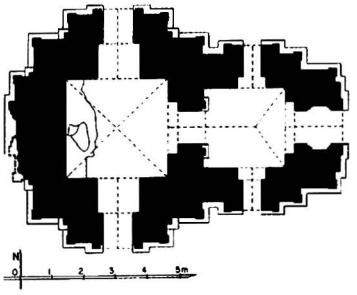
1991 a - Plan

5 present condition
- east porch destroyed.
- repaired (Arch. Dept.) 1966.
- brick grilles built by Arch. Dept.

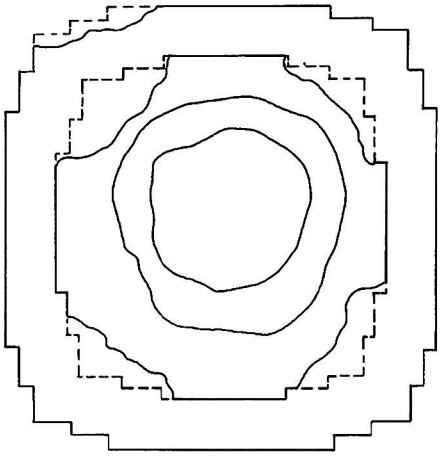
1993 a - Plan

5 present condition
- half-ruined.
- terraces badly damaged.
- upper parts destroyed.

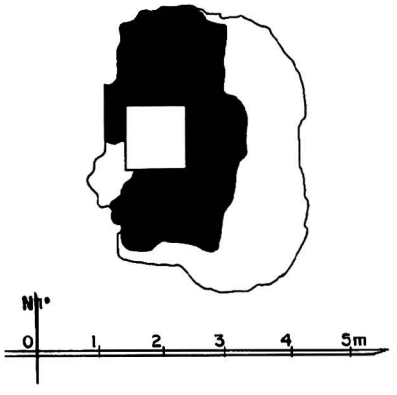
1995 a - Plan

5 present condition
- ruined.
- terraces disintegrated.
- upper parts destroyed.

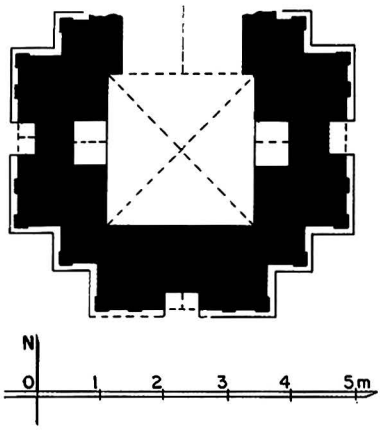
1999 a - Plan

5 present condition
- ruined.
- north porch destroyed.
- vaults and upper parts collapsed.

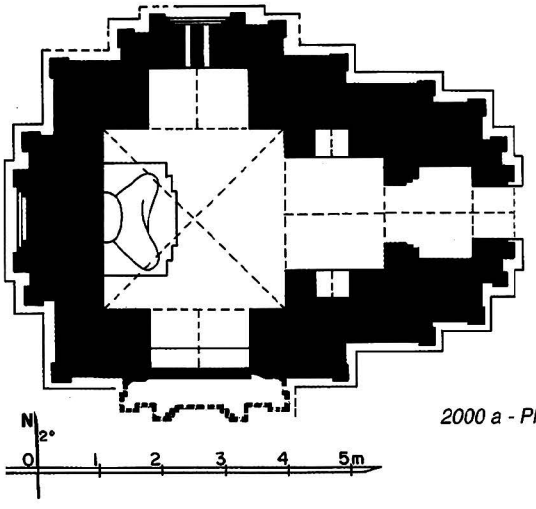
2000 a - Plan

5 present condition
- no maintenance.
- base disintegrated.
- structure badly cracked.
- upper parts nearly destroyed.

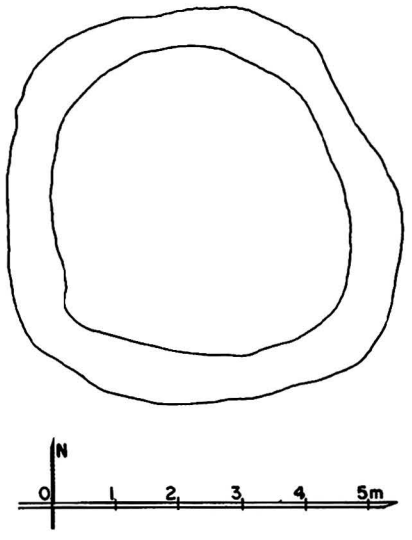
2001 a - Plan

5 present condition
- ruined.
- terraces disintegrated.
- upper parts destroyed.

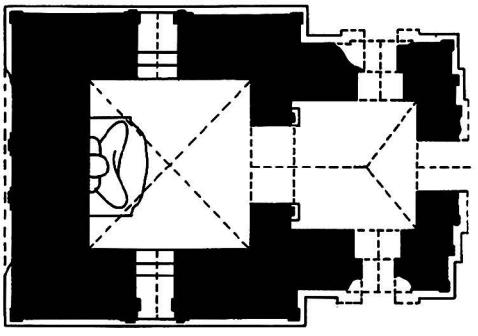
2002 a - Plan

5 present condition
- upper parts damaged.
- repaired (Arch. Dept.) 1978-79.

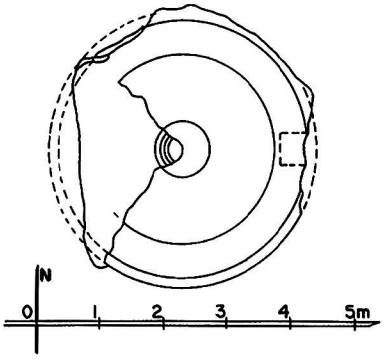
2004 a - Plan

5 present condition
- half-ruined.
- terraces disintegrated.
- upper parts badly damaged.

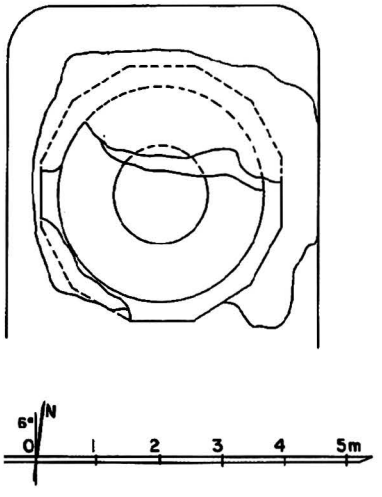
2005 a - Plan

5 present condition
- half-ruined.
- terraces disintegrated.
- upper parts badly damaged.

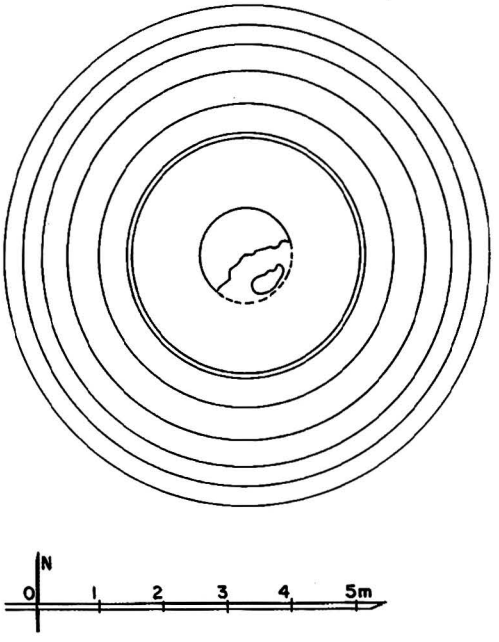
2006 a - Plan

5 present condition
- no maintenance.
- upper parts badly damaged.

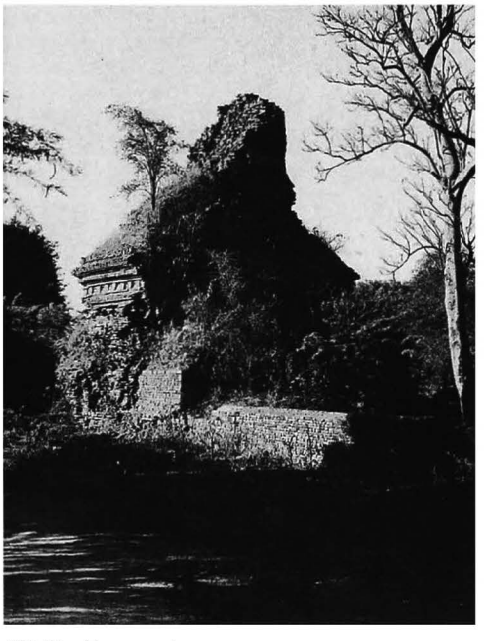
2009 b - From north-east

5 present condition
- half-ruined.
- base and terraces disintegrated.
- upper parts nearly destroyed.

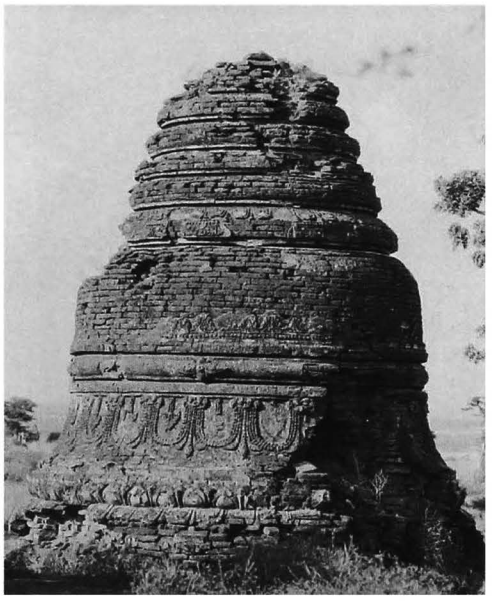
2010 c - Dome, from south

5 present condition
- no maintenance.
- terraces disintegrated.
- upper parts badly damaged.

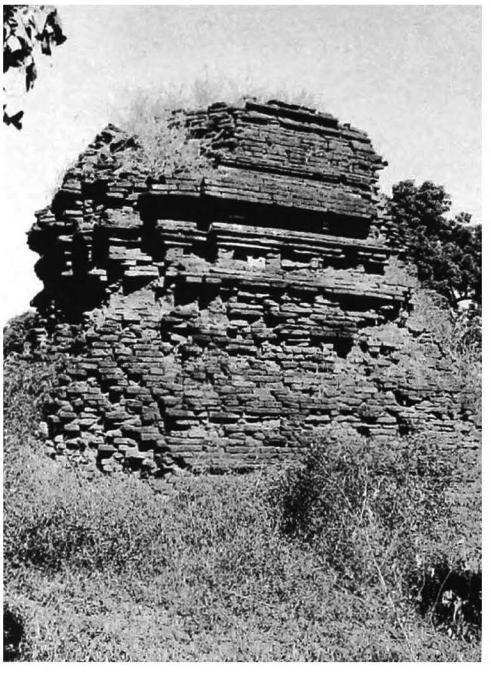
2012 b - South face, from south-west

5 present condition
- half-ruined.
- terraces disintegrated.
- upper parts destroyed.

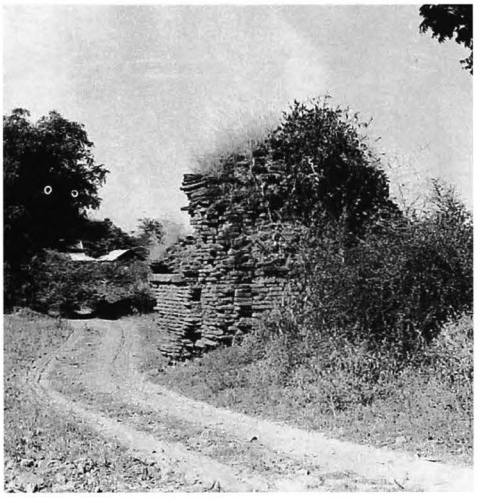
2018 b - From south-east

5 present condition
- ruined.
- base and terraces disintegrated.
- upper parts destroyed.

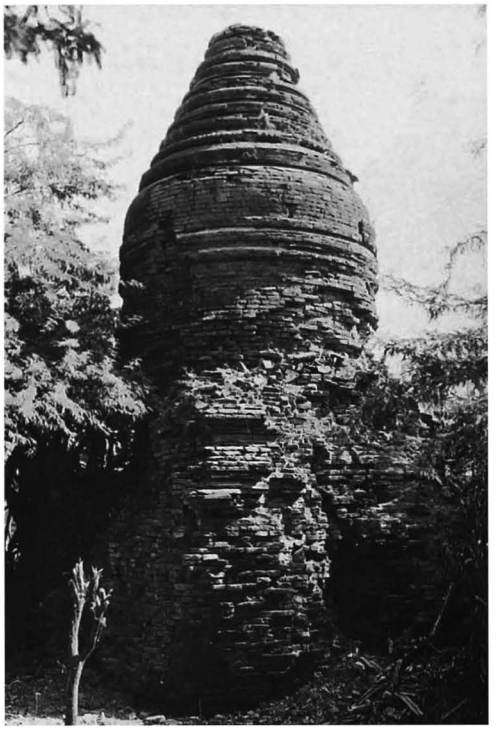
2027 c - From west

5 present condition
- half-ruined and endangered.
- base and terraces disintegrated.
- upper parts damaged.

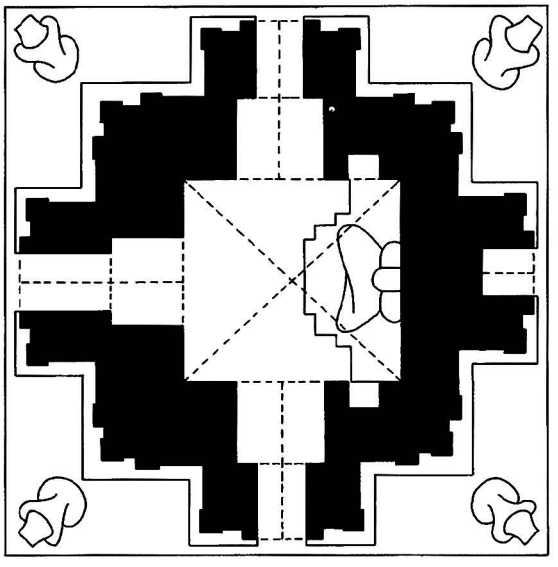
2032 a - Plan

5 present condition
- formerly whitewashed.
- no maintenance.
- upper parts damaged.

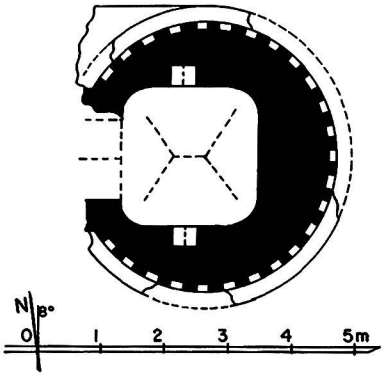
2035 a - Plan

5 present condition
- no maintenance.
- base disintegrated.
- vestibule and porch destroyed.
- upper parts badly damaged.

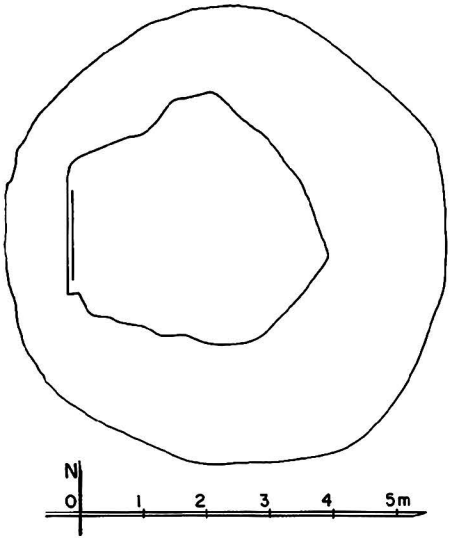
2036 a - Plan

5 present condition
- destroyed by the 1975 earthquake.
- present height 1.70 m.

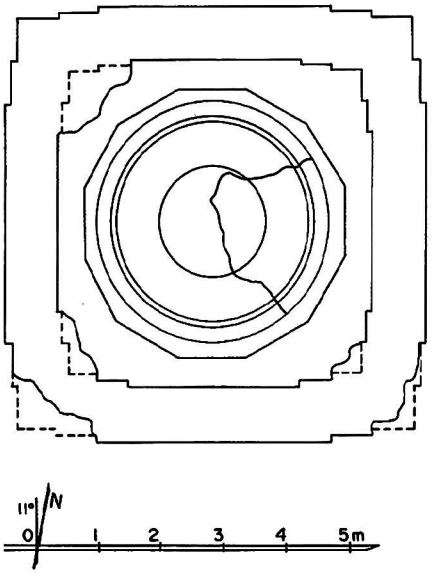
2038 a - Plan

5 present condition
- no maintenance.
- base and terraces damaged.

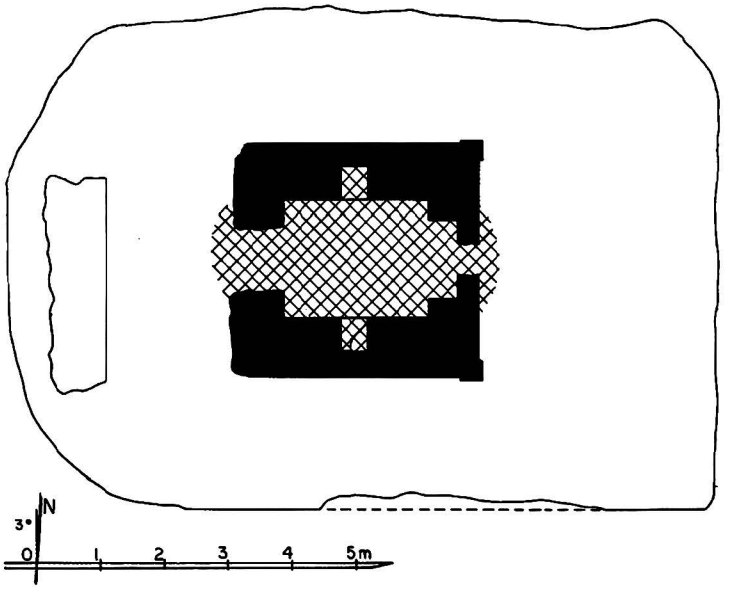
2039 a - Plan

5 present condition
- ruined.
- only base of walls remains.
- ground floor buried under debris.
- present height 2.80 m.

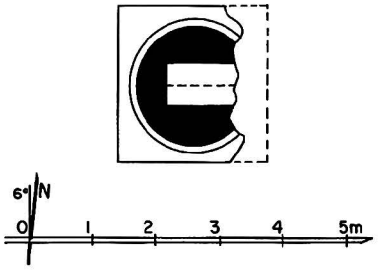
2040 a - Plan

5 present condition
- no maintenance.
- east porch destroyed.
- upper parts nearly destroyed.

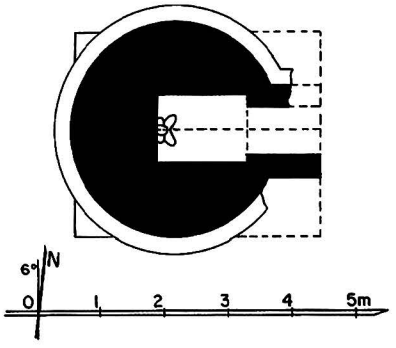
2041 a - Plan

5 present condition
- no maintenance.
- east porch badly damaged.

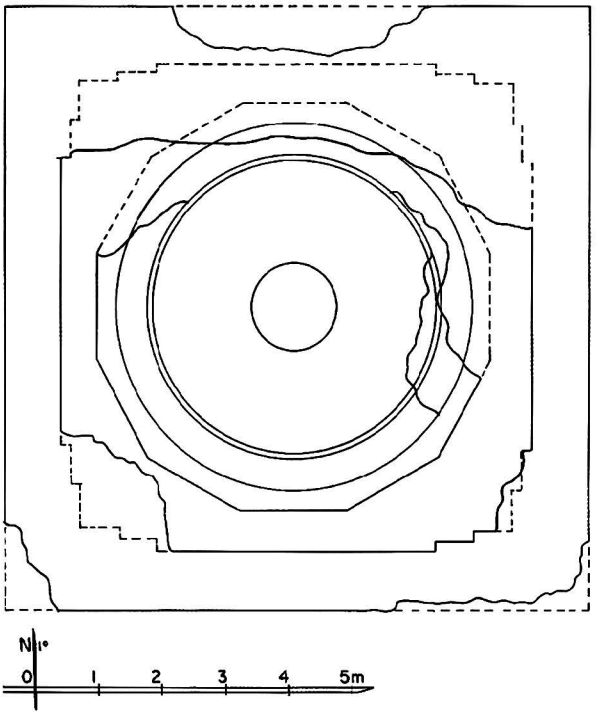
2042 a - Plan

5 present condition
- no maintenance.
- base, terraces and upper parts badly damaged.

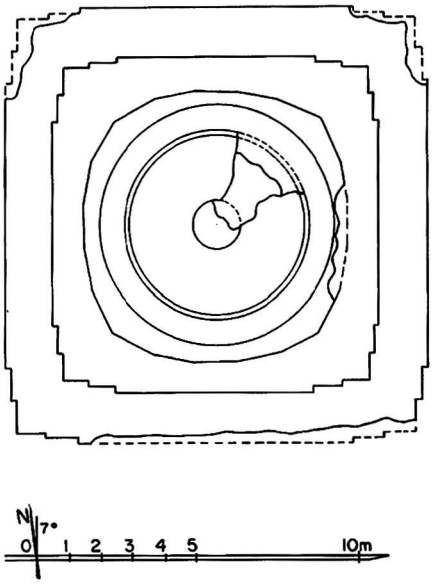
2043 a - Plan

5 present condition
- no maintenance.
- base and terraces damaged.

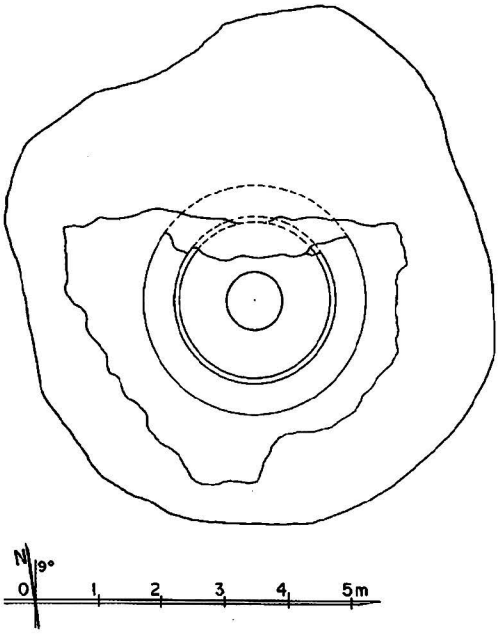
2044 a - Plan

5 present condition
- half-ruined and endangered.
- base and terraces disintegrated.

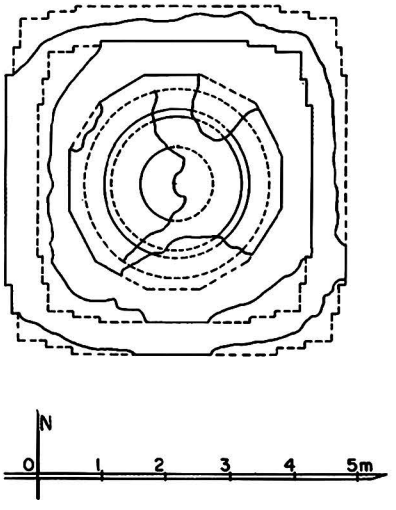
2045 a - Plan

5 present condition
- half-ruined.
- base, terraces and upper parts badly damaged.

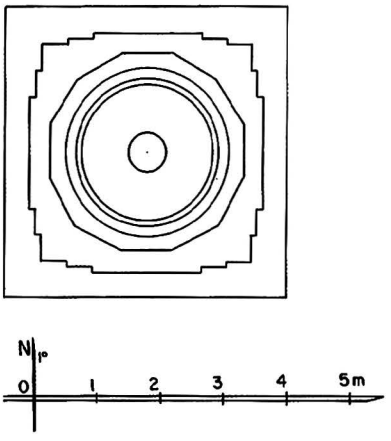
2046 a - Plan

5 present condition
- no maintenance.
- base damaged.

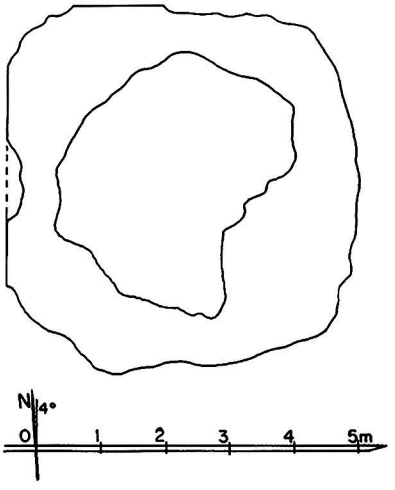
2047 a - Plan

5 present condition
- ruined.
- terraces disintegrated.
- upper parts nearly destroyed.

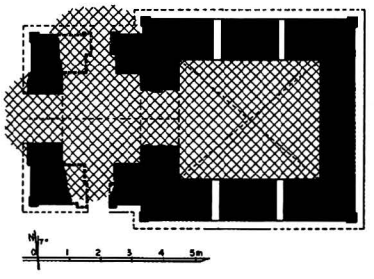
2048 a - Plan

5 present condition
- ruined.
- vaults and upper parts collapsed.
- structure badly cracked.
- ground floor buried under debris.

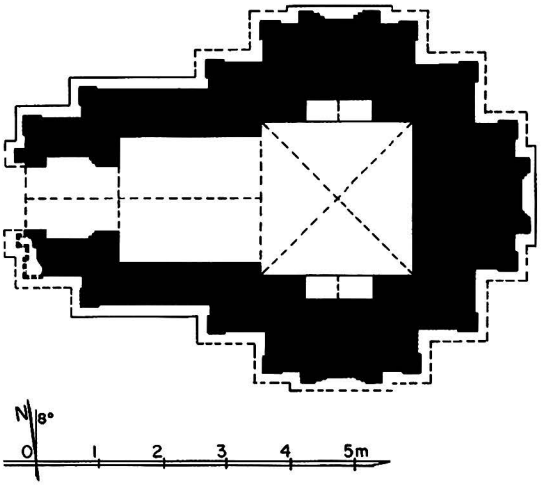
2049 a - Plan

5 present condition
- half-ruined.
- base disintegrated.
- upper parts nearly destroyed.

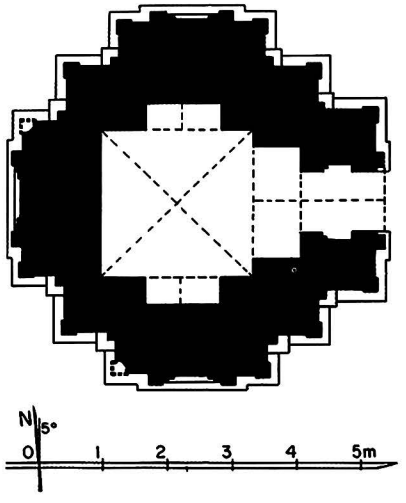
2050 a - Plan

5 present condition
- no maintenance.
- base disintegrated.
- pediments destroyed.
- upper parts badly damaged.

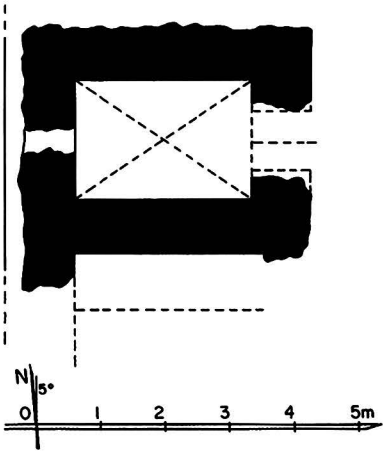
2051 a - Plan

5 present condition
- half-ruined.
- outer walls collapsed.
- upper-storey vaults and upper parts collapsed.

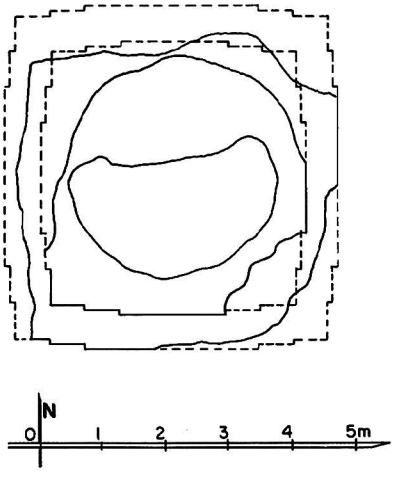
2052 a - Plan

5 present condition
- half-ruined.
- base and terraces disintegrated.
- upper parts destroyed.

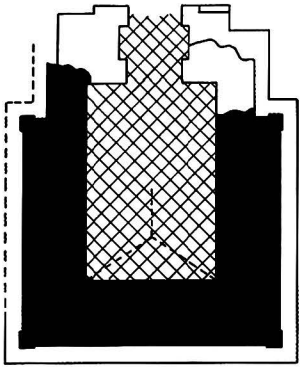
2053 a - Plan

5 present condition
- upper parts badly damaged.
- ground floor buried under debris.
- repaired (Arch. Dept.) 1987.

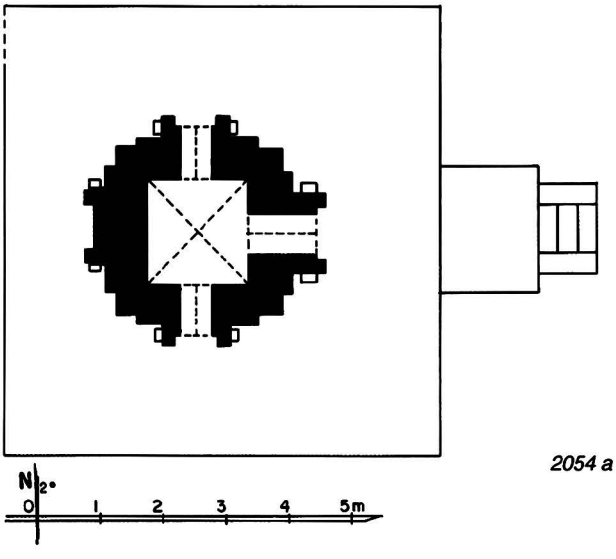
2054 a - Plan

5 present condition
- no maintenance.
- upper parts destroyed.

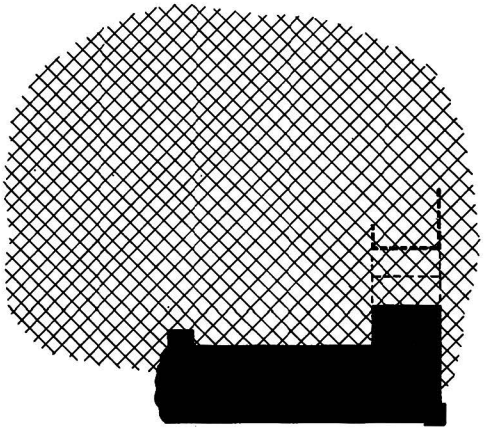
2055 a - Plan

5 present condition
- ruined.
- only part of south wall remains.
- vaults and upper parts collapsed.
- ground floor buried under debris.

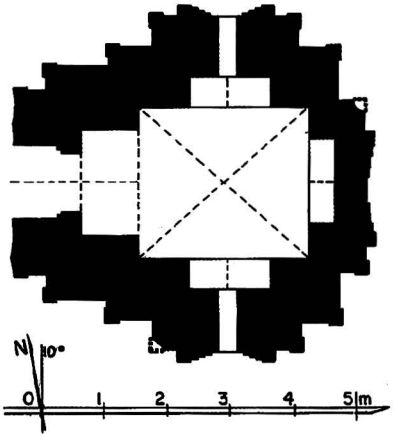
2056 a - Plan

5 present condition
- no maintenance.
- base disintegrated.
- west porch destroyed.
- upper parts badly damaged.

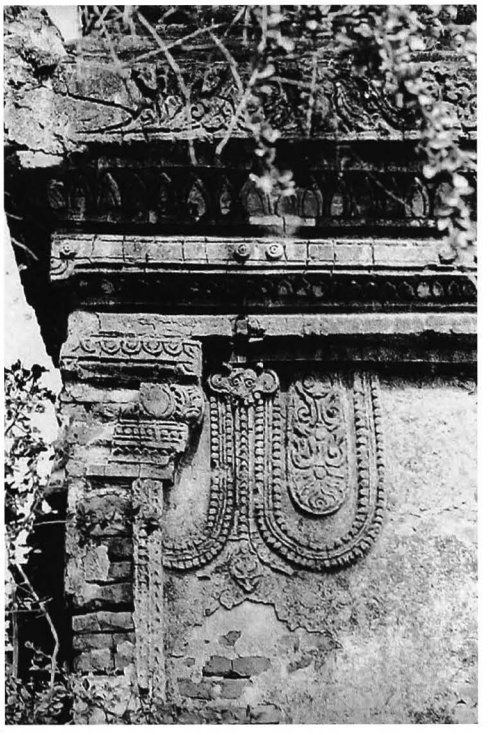
2056 c - East face, south-east corner, detail of frieze and cornice

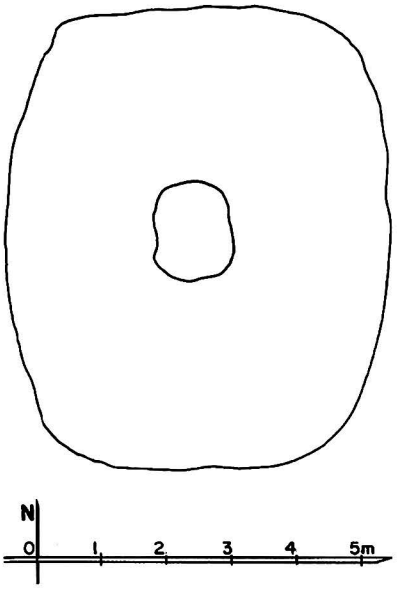
2057 a - Plan

1 general description
- small unexcavated mound.

5 present condition
- brick debris from size 32 x 13 x 4 cm.
- present height: approx. 2.00 m.

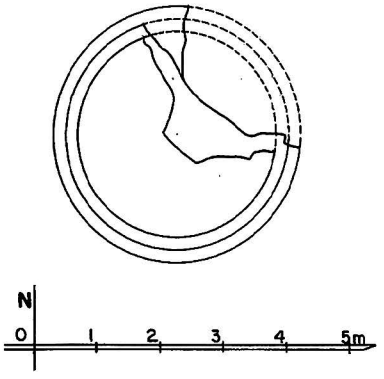
2058 a - Plan

1 general description
- small stupa.

5 present condition
- half-ruined.
- terraces damaged.
- upper parts destroyed.
- present height: 1.60 m.

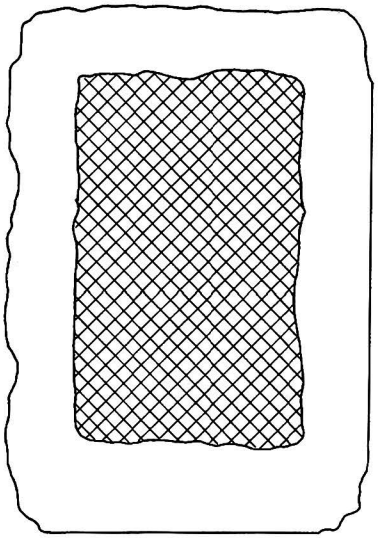
2059 a - Plan

5 present condition
- present height: approx. 2.20 m.

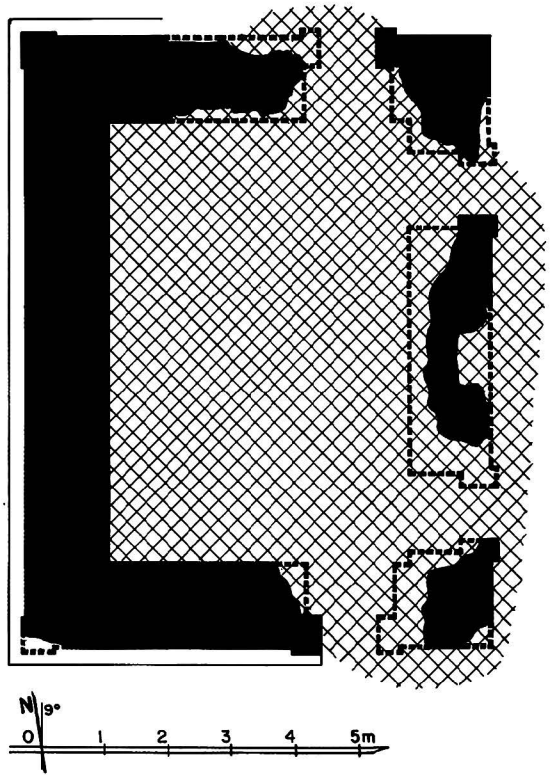
2060 a - Plan

1 general description
- small single-storey monastery.
- at the centre of a ruined walled enclosure.

5 present condition
- ruined.
- vault and roof collapsed.
- ground floor buried under debris.

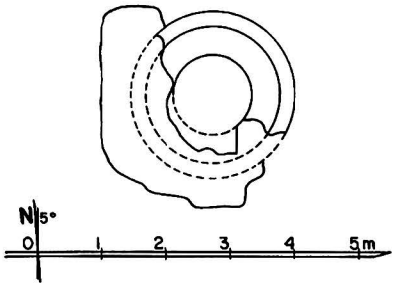
2061 a - Plan

1 general description
- small stupa.

5 present condition
- ruined.
- terraces disintegrated
- upper parts nearly destroyed.
- buttressed 1987.

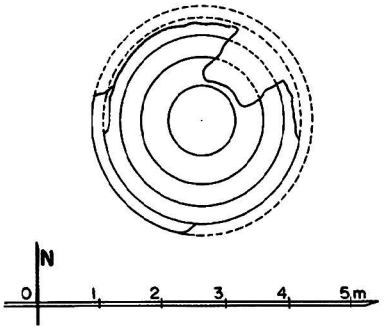
2062 a - Plan

1 general description
- small stupa.

5 present condition
- half-ruined.
- terraces disintegrated.
- upper parts badly damaged.

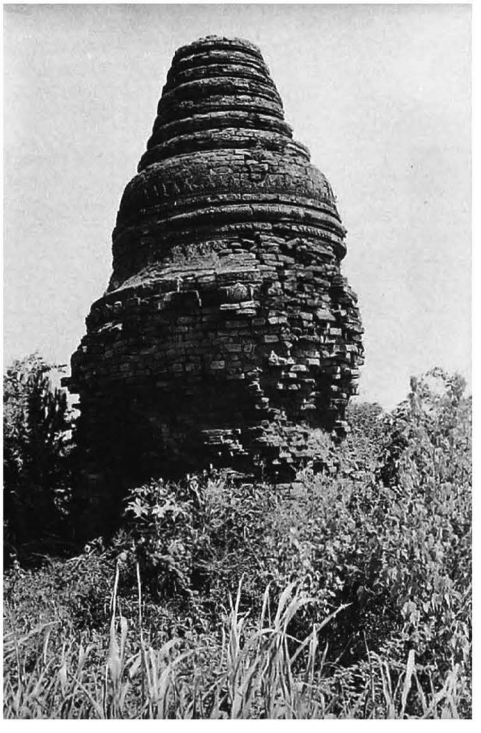
2062 b - South face

2062 c - Dome, from north-west

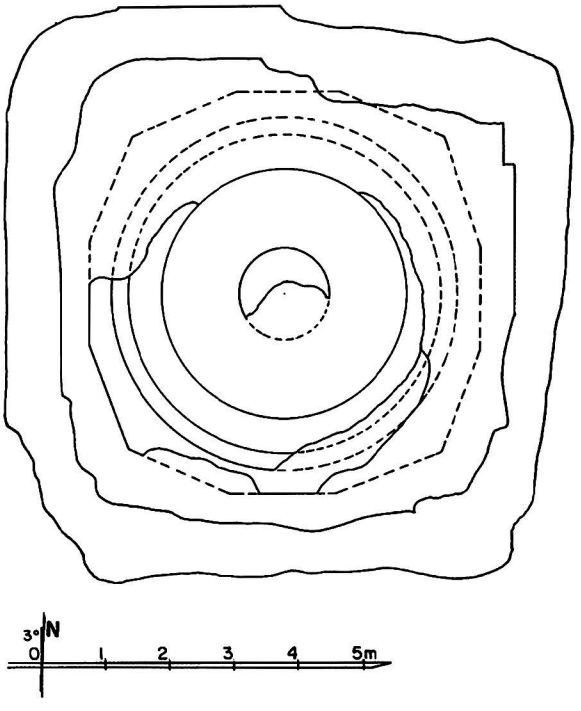
2063 a - Plan

1 general description
- small stupa.

5 present condition
- no maintenance.
- terraces disintegrated.
- upper parts damaged.

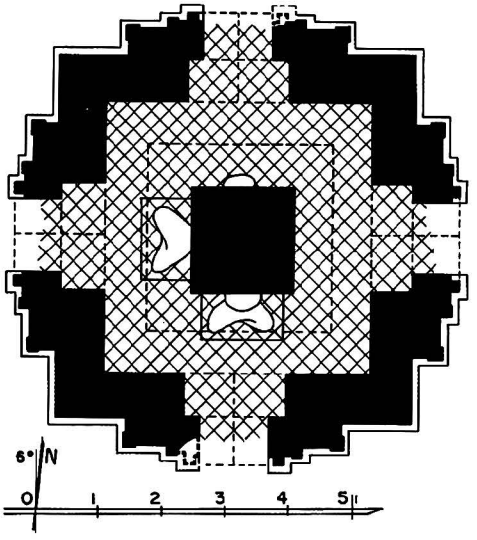
2064 a - Plan

1 general description
- small single-storey temple.

5 present condition
- no maintenance.
- vaults and terraces collapsed.
- ground floor buried under debris.

6 images
- 4 seated Buddhas (disappeared on east, damaged and headless on north and south, legs only remain on west).

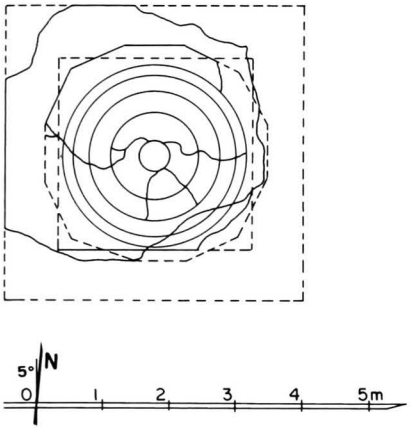
2065 a - Plan

5 present condition
- half-ruined.
- base and terraces disintegrated.
- upper parts nearly destroyed.

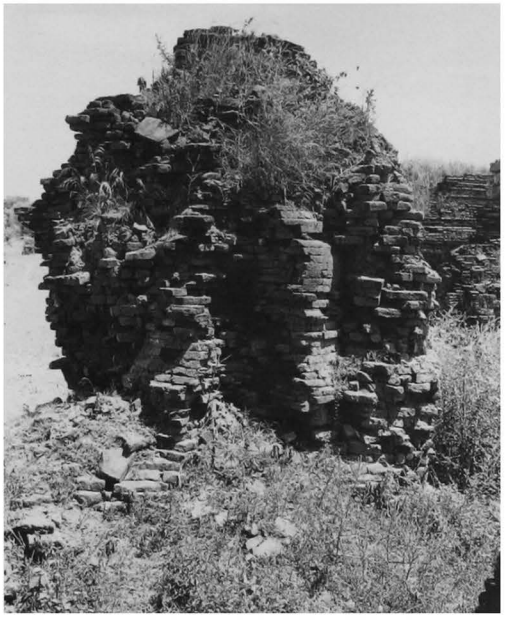
2065 b - South face showing encased stupa

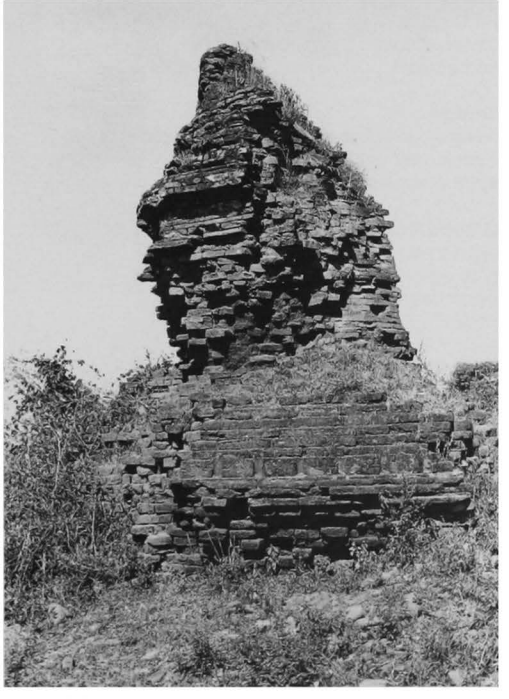
2065 c - West face

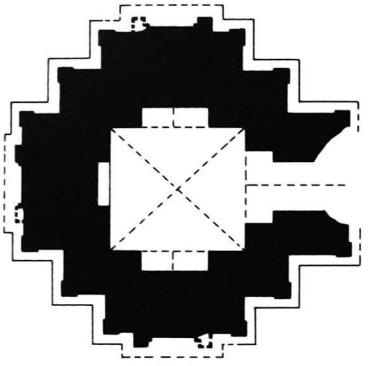
2066 a - Plan

5 present condition
- no maintenance.
- east porch destroyed.
- upper parts nearly destroyed.

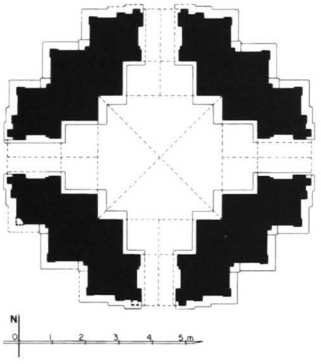
2067 a - Plan

1 general description
- small single-storey temple.

5 present condition
- ruined.
- only parts of south and west walls remain.
- vaults and upper parts collapsed.
- ground floor buried under debris.

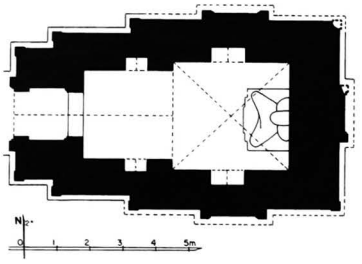
2068 a - Plan

1 general description
- small single-storey temple.

5 present condition
- no maintenance.
- base disintegrated.
- east wall cracked.
- upper parts badly damaged.

6 image
- 1 seated Buddha, facing west (damaged).

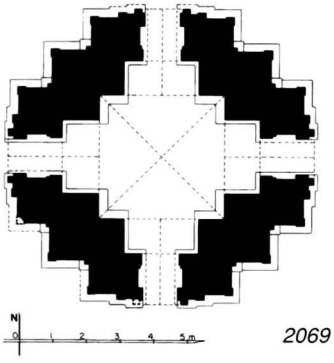
2069 a - Plan

5 present condition
- no maintenance.
- base disintegrated.
- structure cracked.
- upper parts damaged.

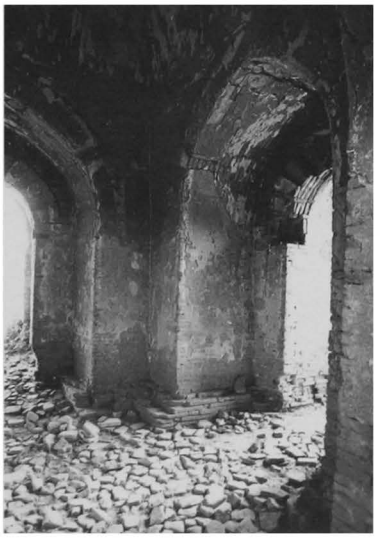
2069 d - Shrine, north-east corner, from south-west

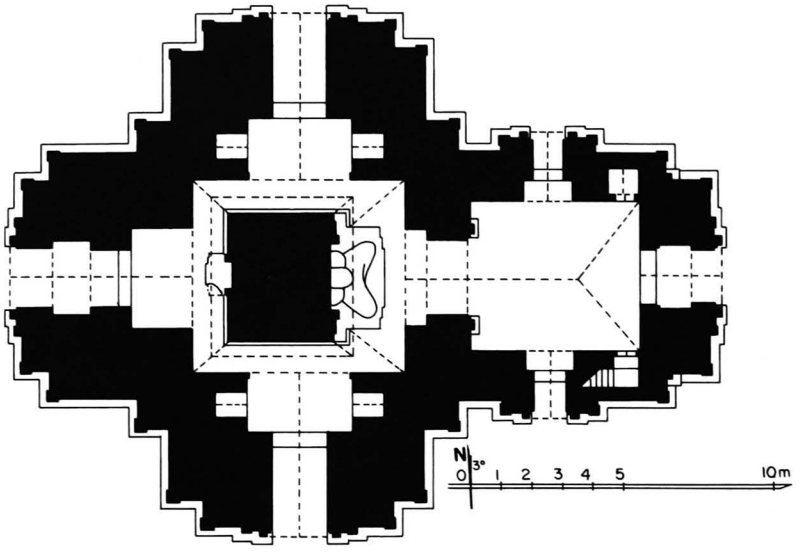
2070 a - Plan

2070 b - From south-west, together with 2069

5 present condition
- upper parts damaged.

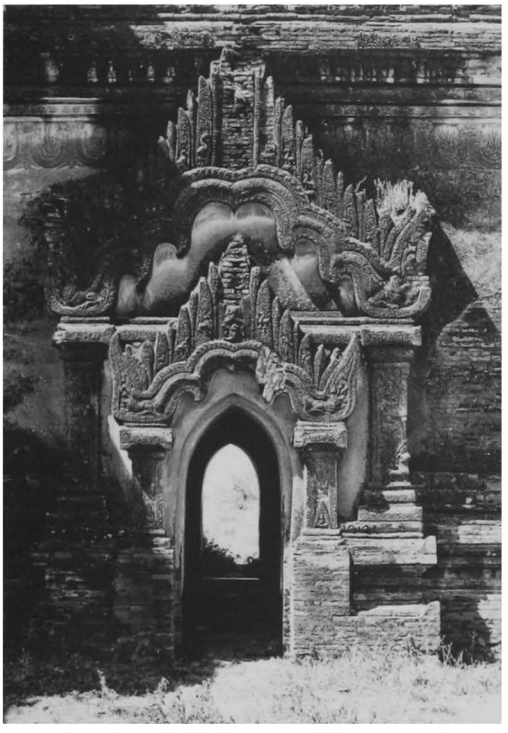
2070 d - East forepart, south lateral porch

2070 e - South forepart, east face, corner pilaster and frieze

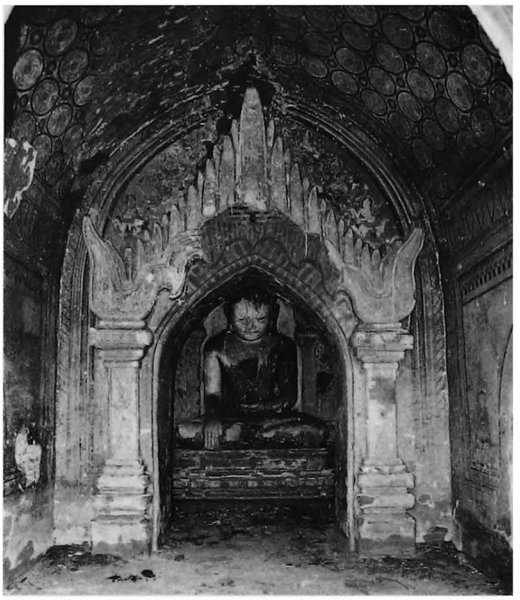
2070 i - Entrance hall, passage and image, from east

2070 j - Entrance hall vault, detail from north

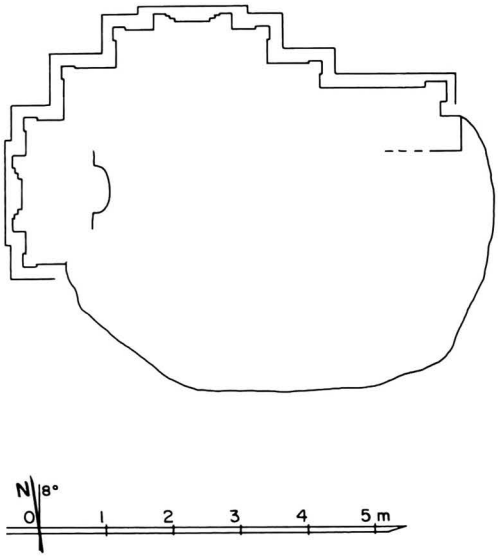
2071 a - Plan

1 general description
- small single-storey temple.

5 present condition
- ruined.
- only base of north and west walls remains.
- vaults and upper parts collapsed.
- ground floor buried under debris.

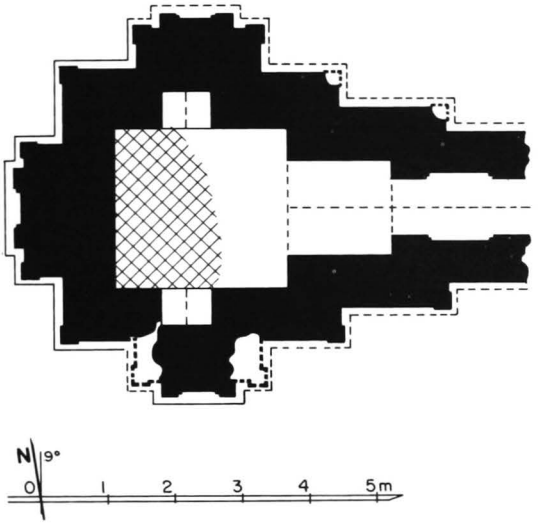
2072 a - Plan

1 general description
- small single-storey temple.
- in north-east corner of the walled enclosure of temple **2070 Yin-ma-na-hpaya**.

5 present condition
- half-ruined.
- vaults and upper parts collapsed.
- structure badly cracked.
- ground floor partly buried under debris.

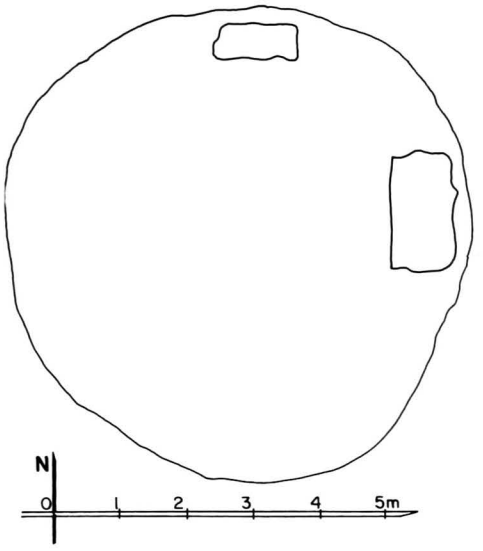
2073 a - Plan

1 general description
- small unexcavated mound.
- in a ruined walled enclosure, together with monasteries **2074**, **2075** and mound **2414**.

5 present condition
- brick debris from various sizes, including 46 x 23 x 8 cm.
- present height: approx. 2.80 m.
